CHARACTERIZATION OF TURBINE CERAMICS AFTER LONG-TERM ENVIRONMENTAL EXPOSURE

GEORGE D. QUINN

Date Published - April 1980

by
ARMY MATERIALS AND MECHANICS RESEARCH CENTER
WATERTOWN, MASSACHUSETTS 02172

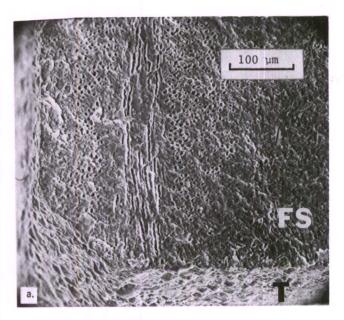
Average retained strength was 211 MPa with a standard deviation of 38 MPa. The Weibull plot of the data indicates one point is uncharacteristically low, but the eleven others can be poorly approximated (85% correlation coefficient) by a line of slope 8.8 (Figure 151). Fracture surface examination again was fruitless with respect to identifying exact failure initiation sites. Close-up examination of the fiber structure reveals the porosity (Figure 160).

Figure 160. (a) Fracture surface of a Silcomp CC combined cycle sample that was broken for a retained strength measurement. The oxide surface layer is badly blistered and damaged; (b) close-up of the porous fiber structure.
